# **CSO POST PROJECT APPRAISAL**

<b>TECHNICAL NOTE REF</b>	<b>:</b>	<b>TRPM – TN003</b>
<b>AUTHOR</b>	<b>:</b>	<b>BARRY THOMPSON</b>
<b>VERSION</b>	<b>:</b>	<b>3.0</b>
<b>DATE</b>	<b>:</b>	<b>JANUARY 2016</b>

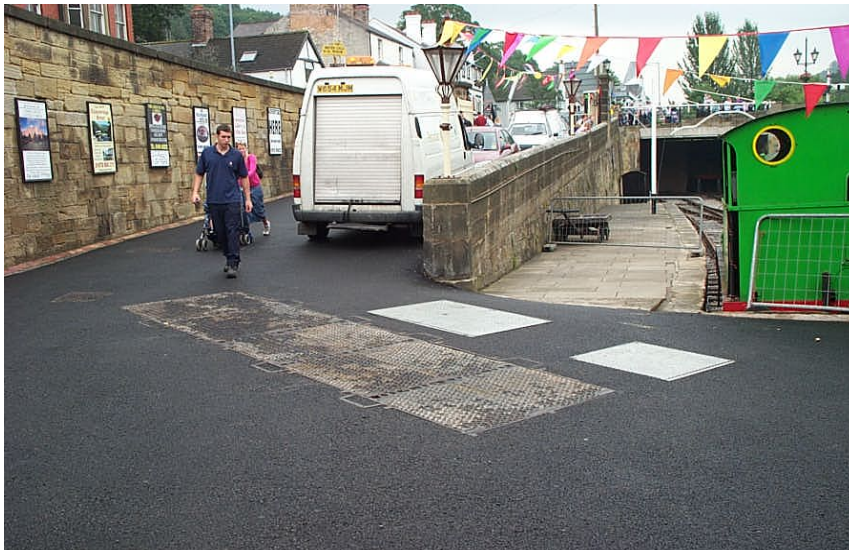
Many appraisals highlighted the issue of access to CSOs being compromised. One instance included a CSO that had been "landscaped" as part of beer garden for a public house on the other side of the road. This was undoubtedly attractive, but there were issues of access (clearing the beer garden if during pub opening hours) and safety, and also possible odour complaints. In another instance, a CSO was located within a major tourist attraction (see Photograph 1), again risking safety issues and odour complaints.

**Photograph 1 – CSO within major Tourist Attraction**

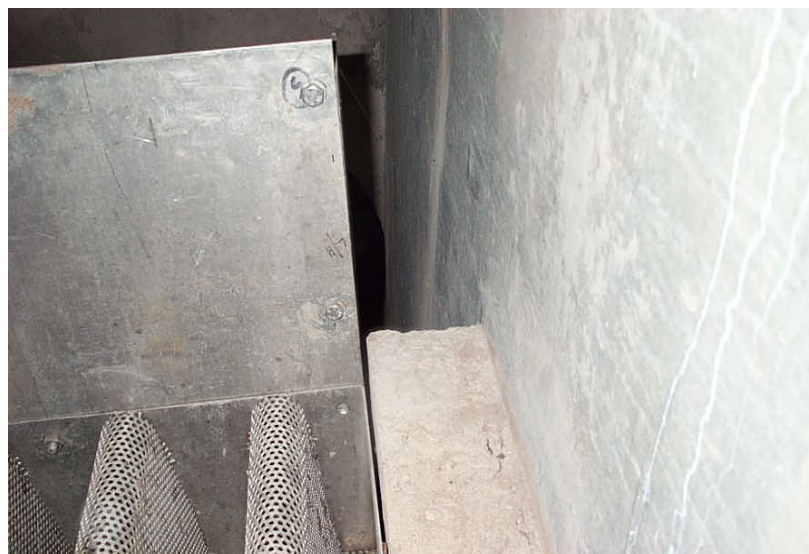
Several examples of basic poor installation were found. In one instance, the screen holding down fixings were clearly inadequate and the entire screen had lifted with the force of upward flow, partly demolishing the brick-built weir. At other locations, poor mechanical installation had created bypass routes (see Photograph 3) through which unscreened flow could be discharged direct to the receiving watercourse.

**Photograph 3 – Unscreened Flow Bypass due to poor Installation**
