# CSO POST PROJECT APPRAISAL

<b>TECHNICAL NOTE REF</b>	<b>:</b>	<b>TRPM – TN003</b>
<b>AUTHOR</b>	<b>:</b>	<b>BARRY THOMPSON</b>
<b>VERSION</b>	<b>:</b>	<b>3.0</b>
<b>DATE</b>	<b>:</b>	<b>JANUARY 2016</b>

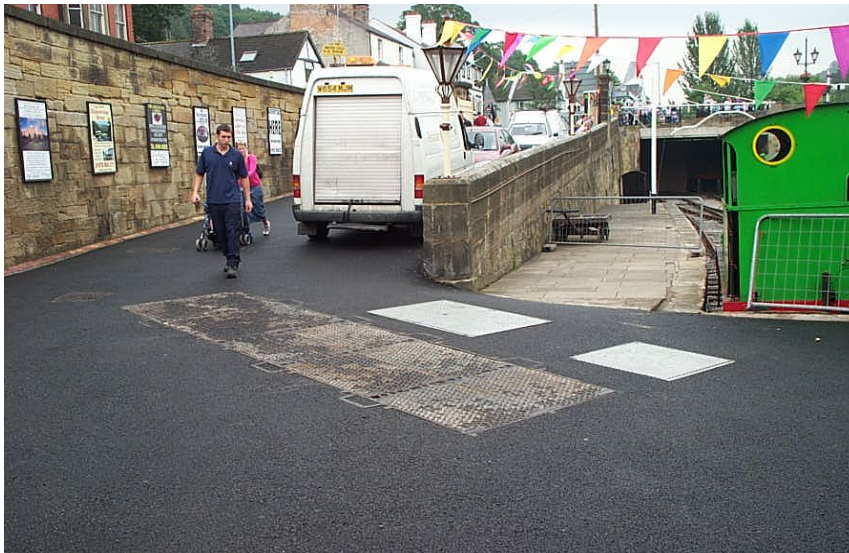
Many appraisals highlighted the issue of access to CSOs being compromised. One instance included a CSO that had been "landscaped" as part of beer garden for a public house on the other side of the road. This was undoubtedly attractive, but there were issues of access (clearing the beer garden if during pub opening hours) and safety, and also possible odour complaints. In another instance, a CSO was located within a major tourist attraction (see Photograph 1), again risking safety issues and odour complaints.

**Photograph 1 – CSO within major Tourist Attraction**

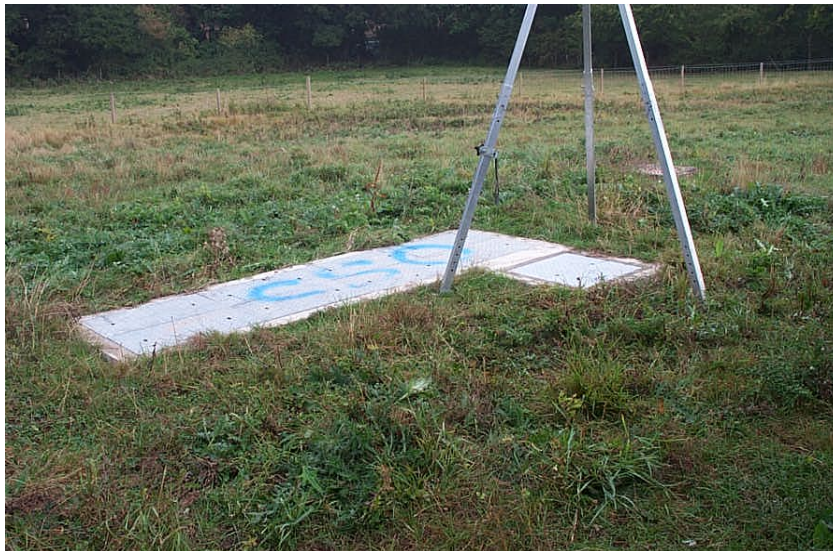
Other examples were found such as a CSO in a field, 200 m from the nearest road, with no water supply, no hard-standing around the manhole and no vehicular access. The lack of hard-standing around a manhole was a common finding (see Photograph 2) and was critical, as it meant that safety tripods / winches could not be used for personnel access. Under Confined Space Entry procedures, this in turn means that access for maintenance was impossible.

**Photograph 2 – No Hard-standing around CSO Personnel Access**

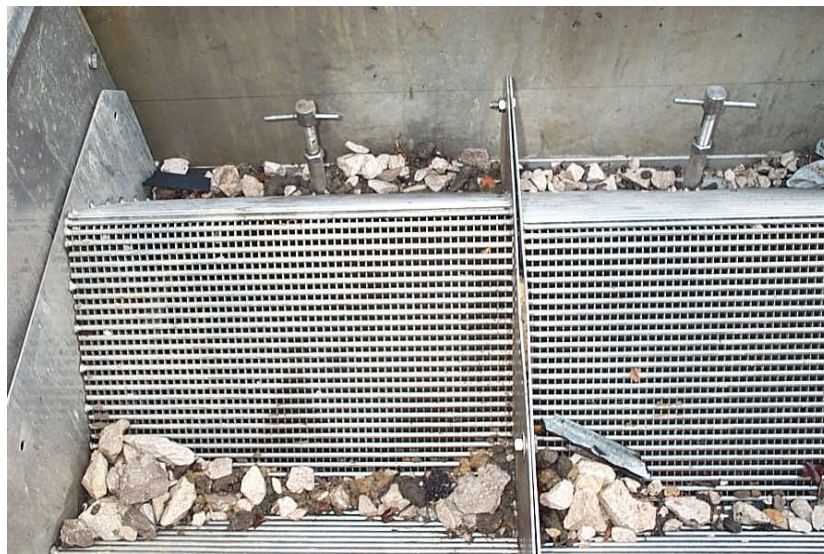
At one or two locations, construction debris that the contractors had failed to remove was found on top of the screen (see Photograph 4), whilst at other locations the undersides of some screens were blinded with solids that should have cleared as flows subsided, thus compromising capacity and performance at the next storm event.

**Photograph 4 – Construction Debris left on top of Screen**
